# Overall Inspection Services LLC

## PROPERTY INSPECTION REPORT

Prepared For: Charlie Brown

Concerning: 1000 Somewhere St, Round Rock, TX 78665

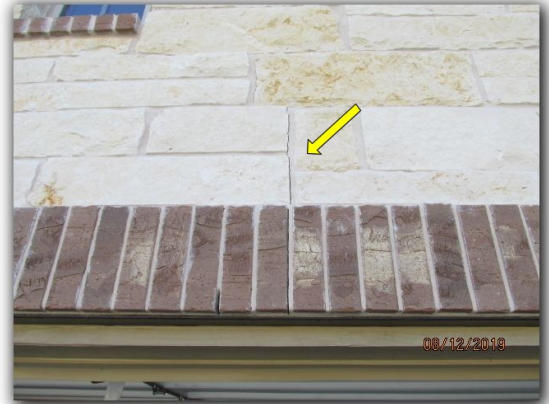
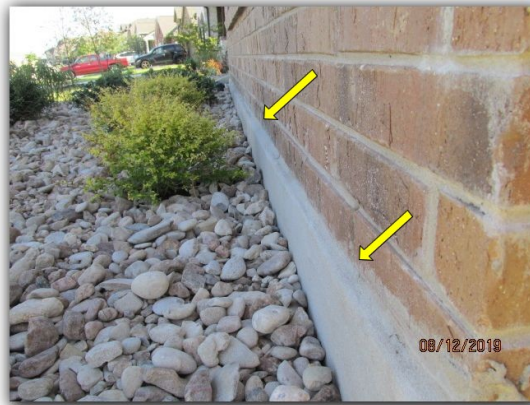
It was observed that there is a small ledge at the brick ledge / foundation connection around the foundation perimeter. Over time, this condition can promote water to sit atop the brick ledge and potentially migrate behind the parge coat of the foundation, thereby making the parge coat more susceptible to deterioration. Monitoring and or repair is recommended.

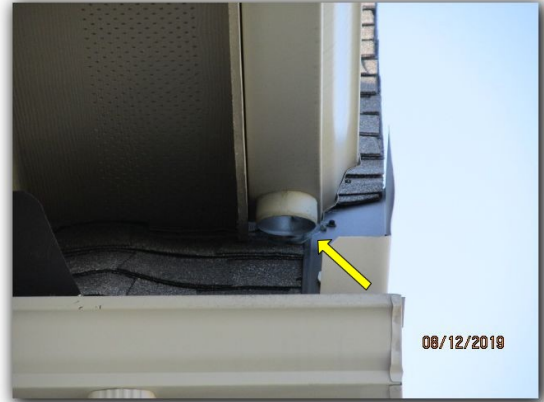
It was observed that the rain gutters have been installed in front of the metal drip edge flashing. The rain gutter should be installed behind the drip edge flashing to help direct roof runoff into the gutter and not between the gutter and fascia, where damage can occur. Repair is recommended.

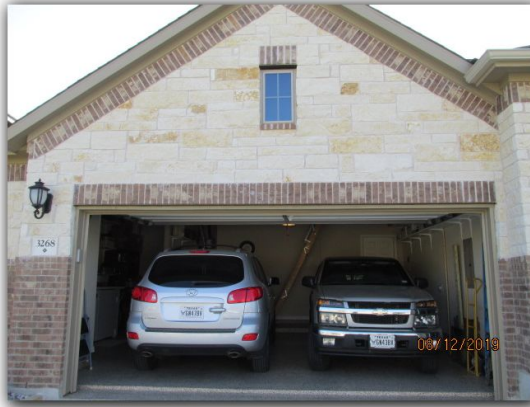
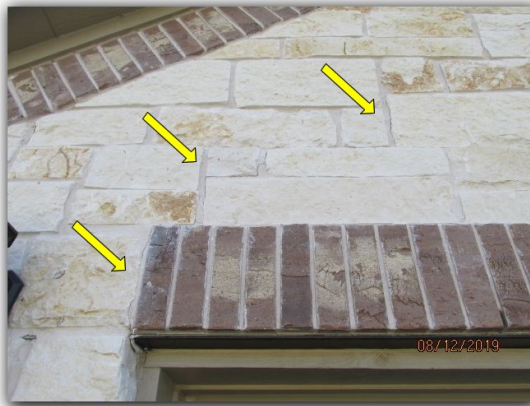
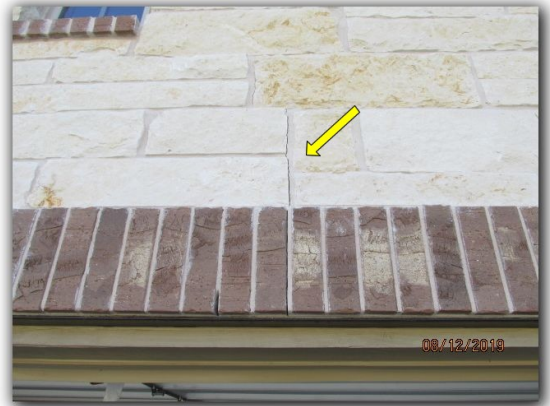
Cracked and or missing caulk was observed in the exterior expansion joints of the brick veneer. Recommend [new / additional caulk](#) to help prevent water / pest intrusion.

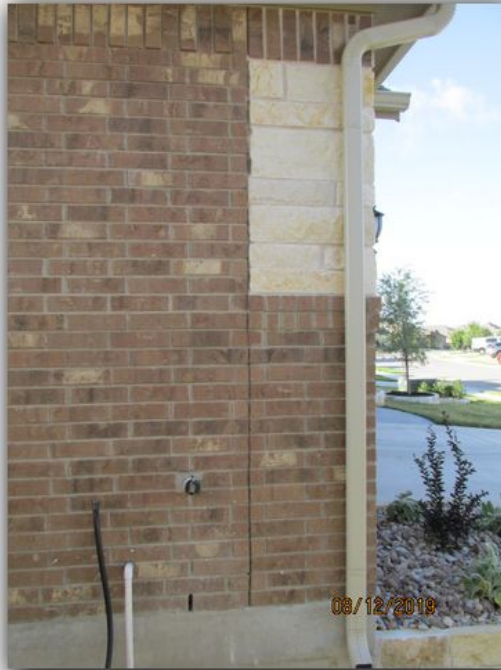
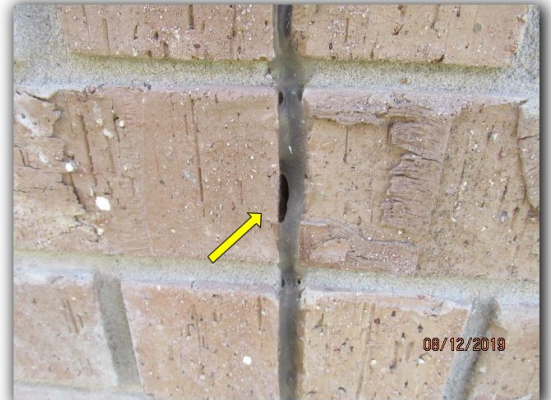
Missing [mortar](#) was observed in the exterior stone / brick veneer. Tuck pointing is recommended to help prevent water and or pest infiltration into the wall cavity.

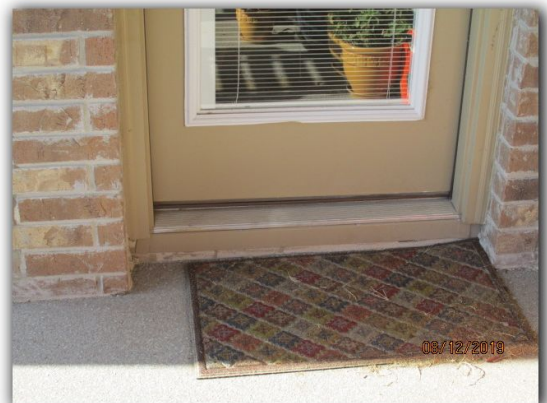
The back porch door appears to be out of square in its jamb also the [weather stripping](#) is in need of repair.

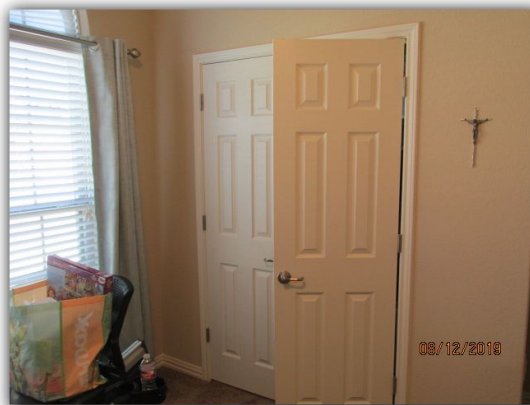
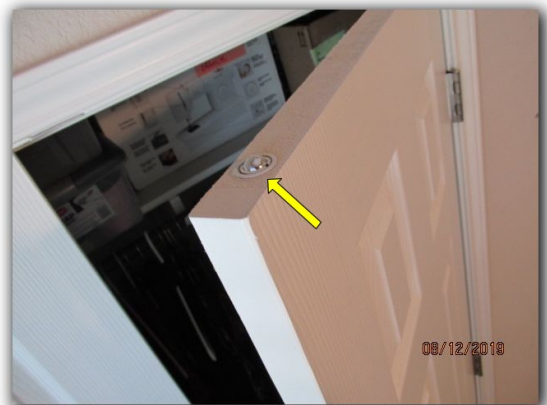
The spring loaded ball latch for some of the closet doors are in need of adjustment to better secure the door when closed. Repair is recommended.

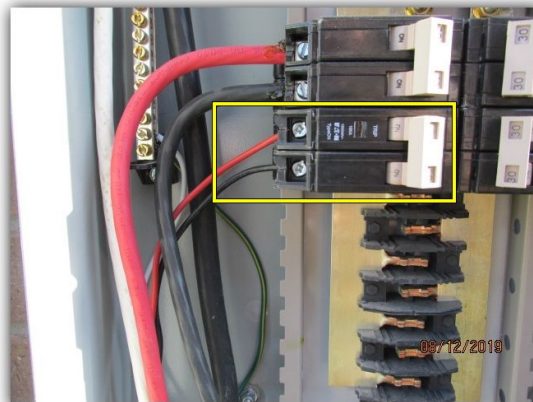
It appears that the #10 AWG conductor is too small for the 50 amp circuit breaker in the main panel. Oversized circuit breaker within the main distribution panel are recommended to be replaced. **This is a safety hazard.** Recommend having a licensed electrician to inspect system.

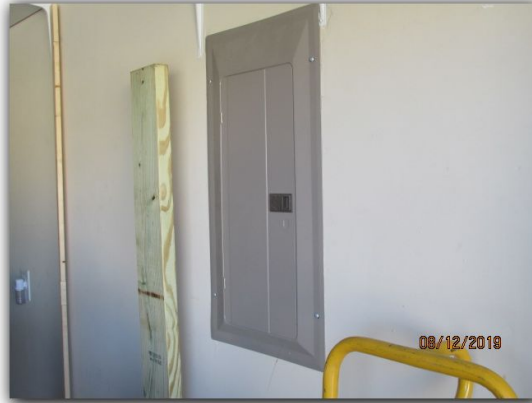
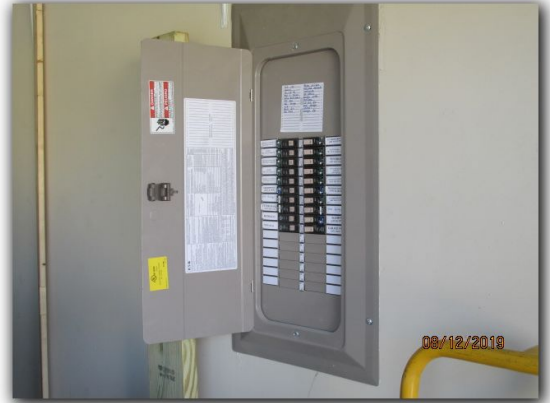
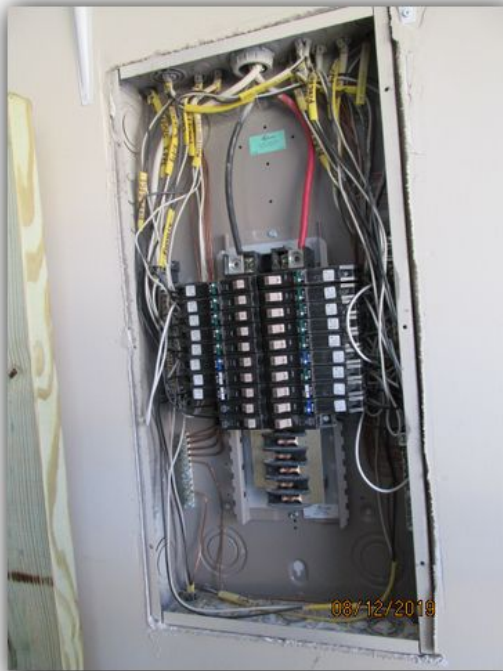
The sub panel was observed to have debris inside the enclosure. Repair is recommended.

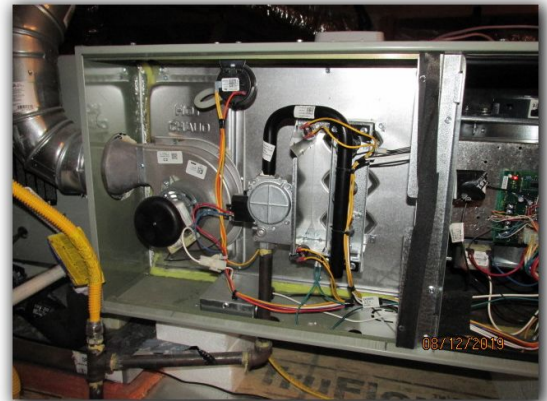
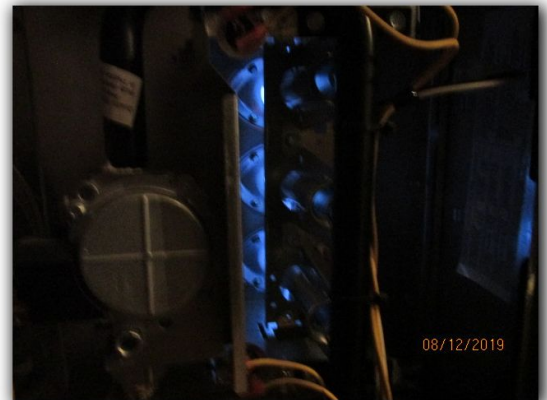
It was observed that the blower door safety switch on the HVAC air handler has been taped down in the "on" position. **This is a safety hazard** and repair is recommended.

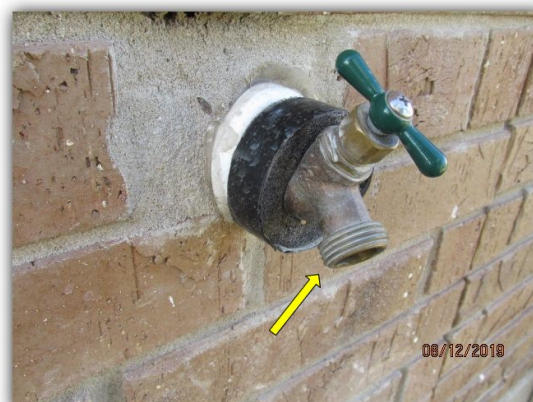
Exterior hosebib faucets do not have the [anti siphon back flow devices](#), as required by current code. Anti-siphon devices keep contaminated water from entering the potable water of the house plumbing. Repair is recommended.

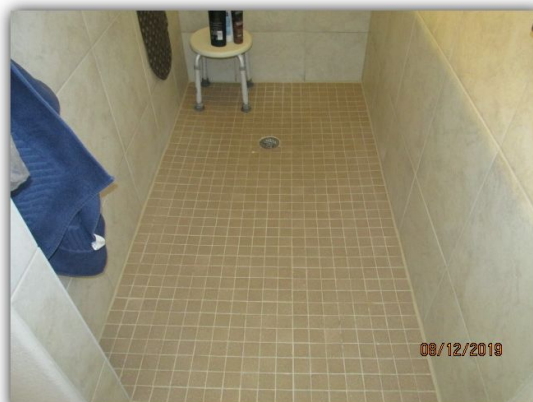
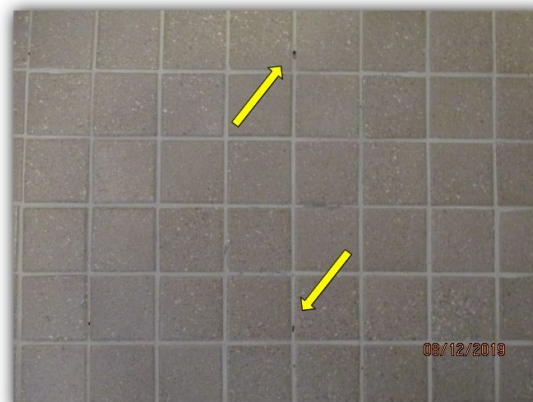
Cracked, deteriorated and/or missing shower stall [grout](#) and [caulk](#) in the master shower should be repaired.

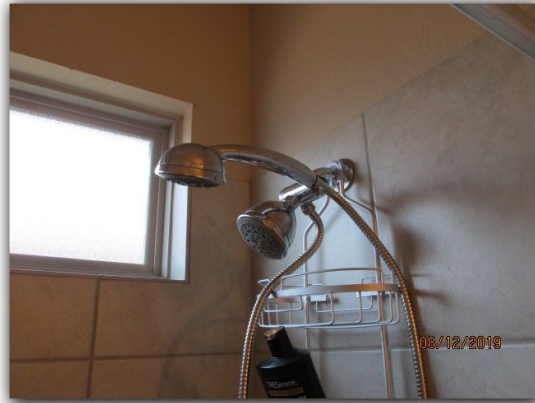
The [shower head](#) shower arm was observed to be leaking and should be repaired or replaced.

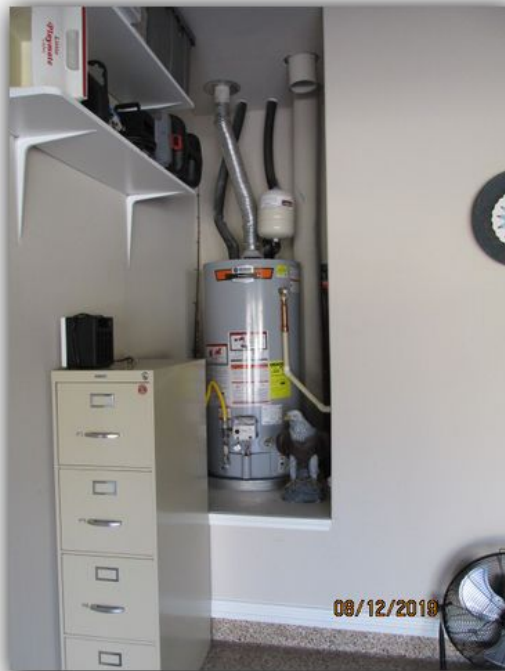
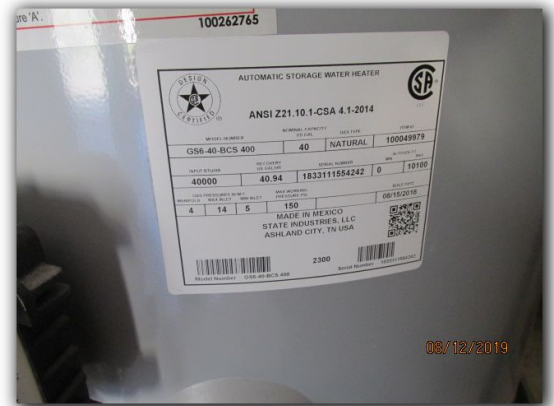
It does not appear that the gas flue pipe is not properly connected to the draft hood with two self tapping screws as required by the manufacturer. Repair is recommended.

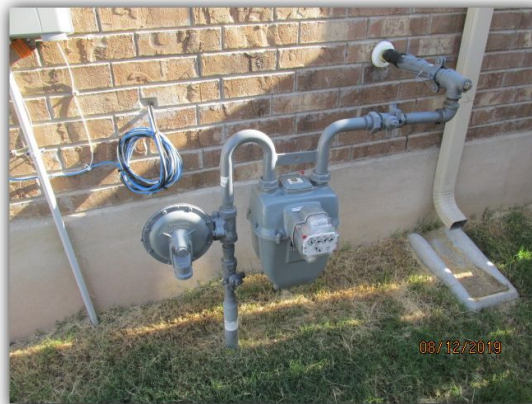
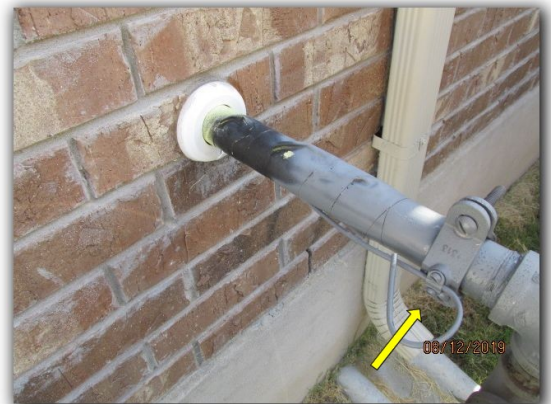
A potentially hazardous condition was observed in the home. It was observed that portions of the gas piping system such as the gas cooktop, water heater(s), fireplace and furnace(s) appear to be composed of corrugated stainless steel tubing (CSST). Manufacturers believe that the product is safe if properly bonded and grounded as required by the manufacturers installation instructions. Proper grounding and bonding of the CSST can be determined by a licensed electrical contractor. Although CSST has been widely utilized in the residential and commercial construction industries for many years and is approved by the local building authority having jurisdiction, according to the Texas State Fire Marshall there are concerns about an increase in lightning related fires and CSST. **It is recommended that all parties, the Seller and the Buyer have the CSST installation, including the electrical bonding inspected by a manufacturer approved CSST installer prior to closing.** The Client is also recommended to check with their home insurance provider regarding the presence of CSST. Since the introduction of CSST, there has been an increase in fire damage caused by lightning strikes. Direct and indirect lightning strikes can energize the tubing, inducing current that attempts to use the metal conduit to reach ground (refer to Section I A: Foundations). The corrugated design and thin walls of the CSST cannot withstand the energy produced, causing a hole to be melted in the CSST. That hole results in the release of pressurized natural gas or propane into the home, which can immediately ignite and can rapidly fuel a fire. Further evaluation is required by a licensed master electrician. Click the attached link below for more information...

It was observed that the black jacket for the CSST has not been properly installed with the brass connector placed over the black jacketed sleeve and aluminum sleeve as required by the manufacturer. **This is a safety hazard.** Further investigation of the CSST and repairs are recommended.

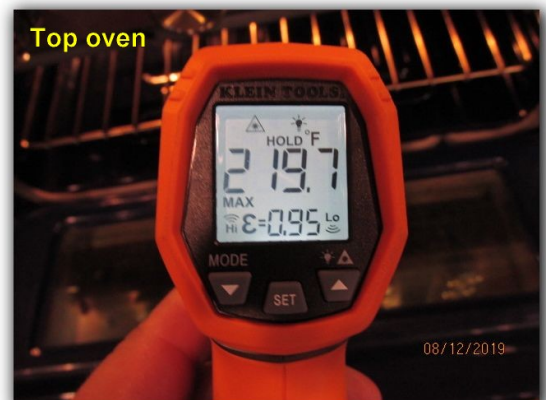
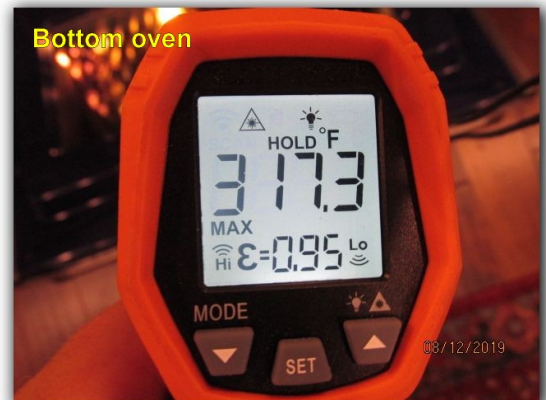
When the oven thermostat alarms sounded, the thermostats for the ovens were found to be inaccurate. The temperature was observed to be greater than a 25 degree difference, either cooler or warmer, of 350 degrees, as measured by a detached thermometer. Recommend further investigation and or repair by a professional appliance technician.

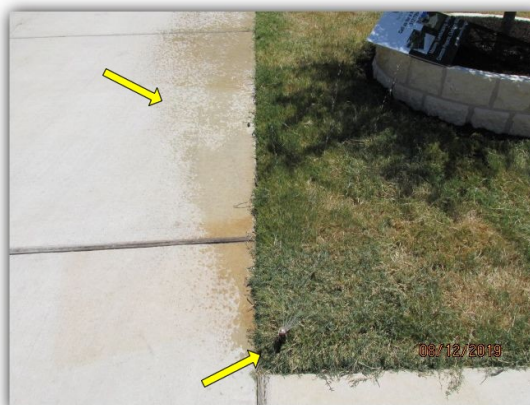
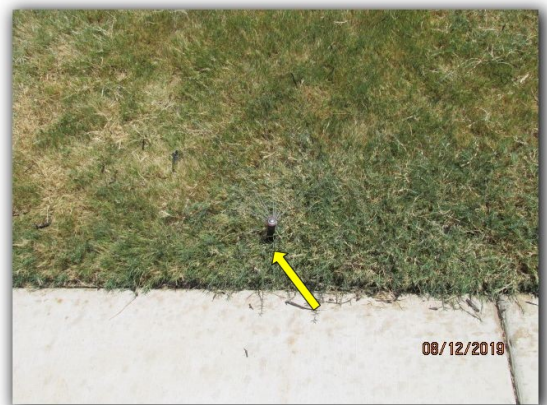
Recommend minor adjustment to the spray head[s] screw to help control overspray and wasting water on hard surfaces.

Recommend minor adjustment to a spray head for improved lawn coverage.

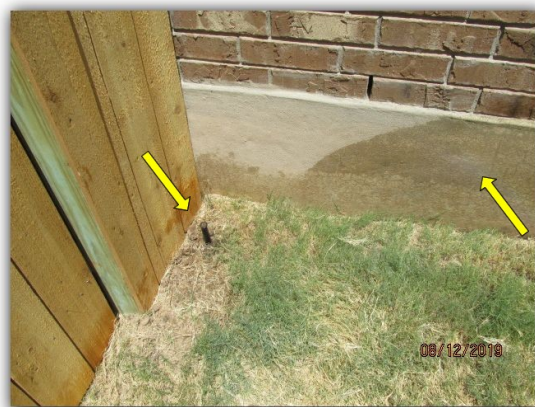
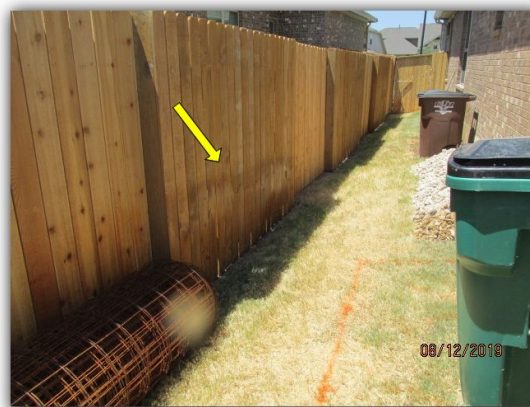
The water spray from the sprinkler heads should be re-directed away from the structure and/or fencing, decks, etc., to decrease the possibility of staining or damage. Changing and or adjusting the spray head[s] may be required.

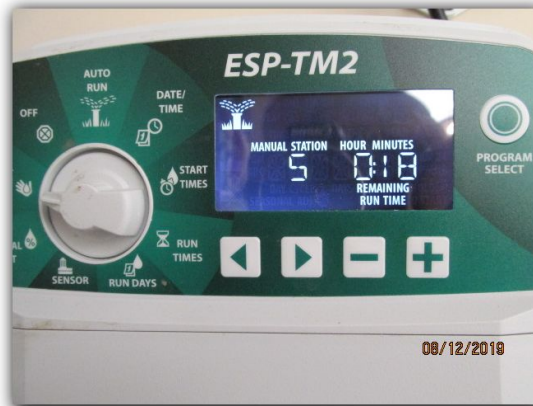
It was observed that this tree well was not watered in zone 5 even though it appears to be connected to the zone. Further investigation is recommended.

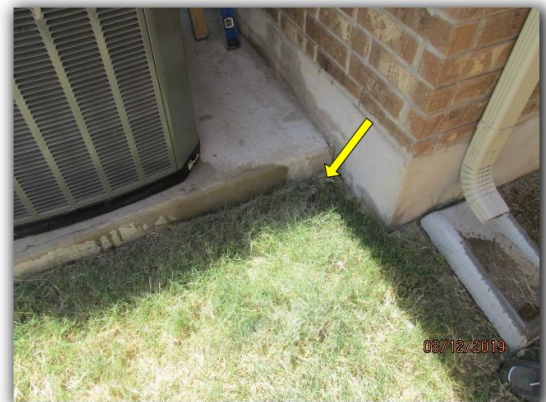
A sprinkler was observed to spray upon the outdoor HVAC unit. Redirecting the sprinkler is recommended.

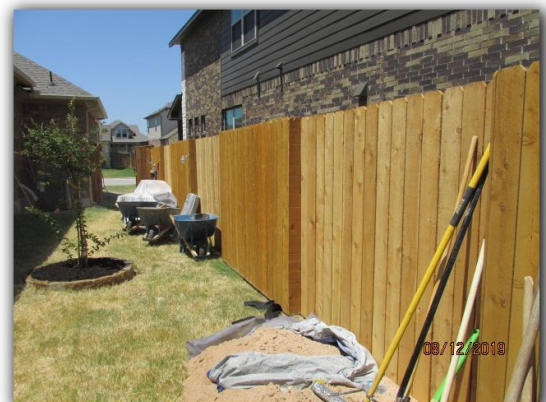
The water spray from the sprinkler heads should be re-directed away from the structure and/or fencing, decks, etc., to decrease the possibility of staining or damage. Changing and or adjusting the spray head[s] may be required.

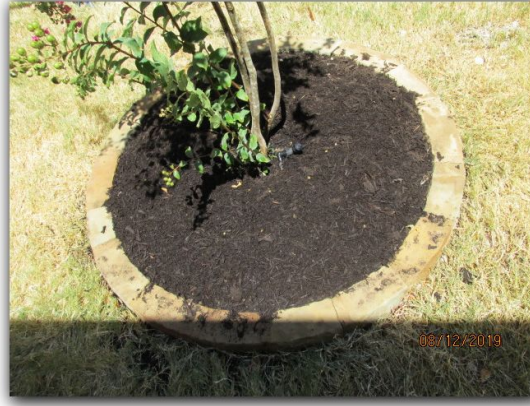
It was observed that this tree well was not watered in zone 6 even though it appears to be connected to the zone. Further investigation is recommended.
