# Overall Inspection Services LLC

## PROPERTY INSPECTION REPORT

Prepared For: Charlie Brown

Concerning: 1000 Somewhere St, Round Rock, TX 78665

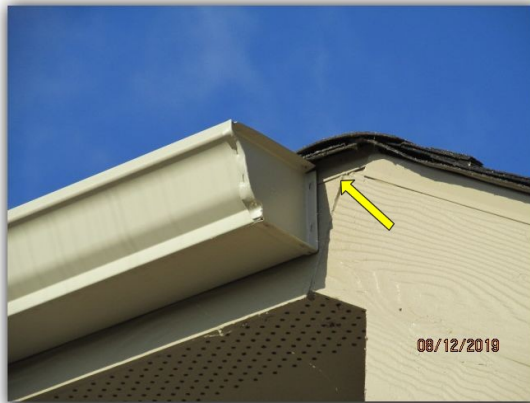
It was observed that the rain gutters have been installed in front of the metal drip edge flashing. The rain gutter should be installed behind the drip edge flashing to help direct roof runoff into the gutter and not between the gutter and fascia, where damage can occur. Repair is recommended.

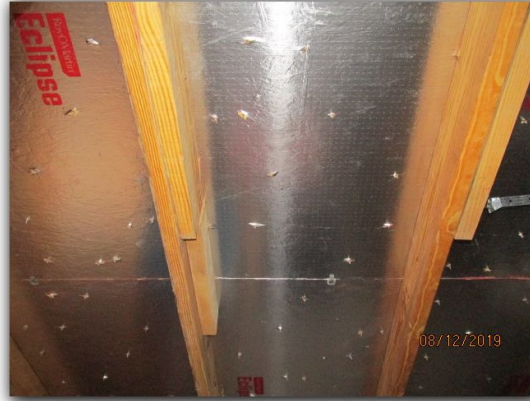
**FYI:** It was observed that the home is decked with a radiant barrier type of roof decking. This type of decking is known to have a negative effect to some cellular providers.

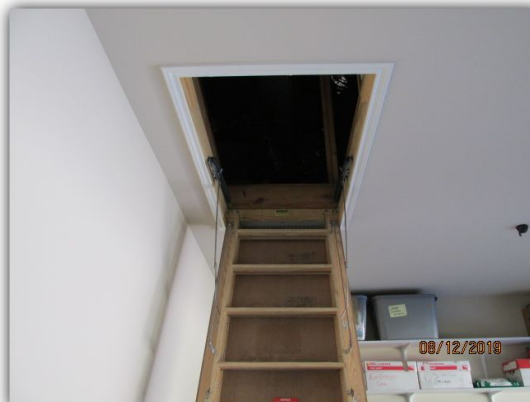
It appears that the attic access stairs have not been installed with the appropriate fasteners per the manufacturer's instructions. [Manufacturers](#) recommend either sixteen [16d nails](#) or sixteen ¼ x 3" lag screws. **This is a safety hazard.** Recommend repair with the appropriate type and quantity of fasteners for proper and safe operation.

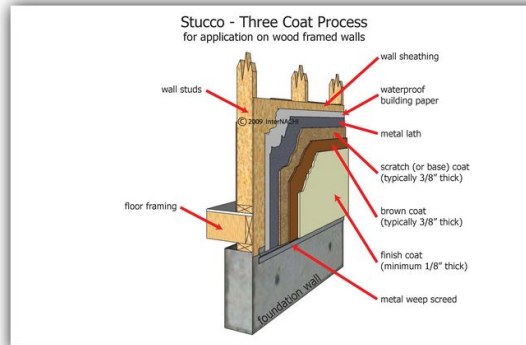
Blocked weep holes (openings in the mortar joints, found at the foundation level, at a maximum of every 33 inches O.C.) in the stone / brick veneer wall structure should be cleared. At times when the brick and mortar are being installed, mortar can fall back into the wall cavity or when the parge coat is applied. The weep holes allow a way for possible water condensation in the wall cavity to drain as well as aid in ventilation of the wall cavity. Repair is recommended.

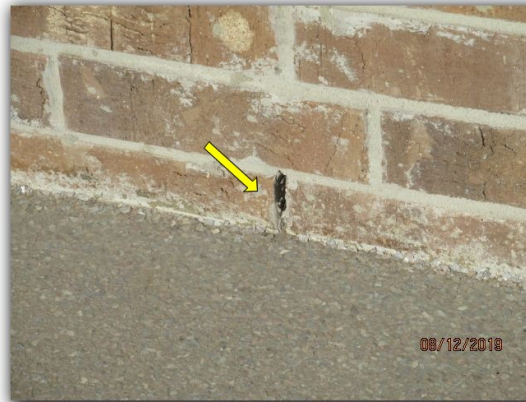
Typical minor cracking was observed in the brick / stone and mortar of the exterior walls in various locations. Brick veneer is not a structural component of or for the home, it simply covers the framed structure. Brick is basically pressed and burnt clay that is not flexible so as the home experiences movement whether uniform or differentially due to seasonal changes, the brick veneer may crack. This implies that some structural movement of the building has occurred, as is typical of most houses. Monitoring and or repairs are recommended.

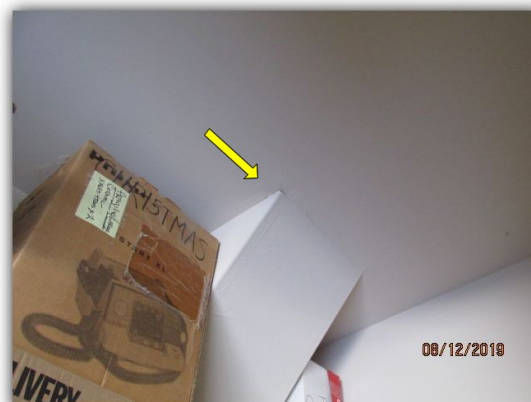
Incomplete drywall tape and bedding was observed in the attached garage. Repair is recommended.

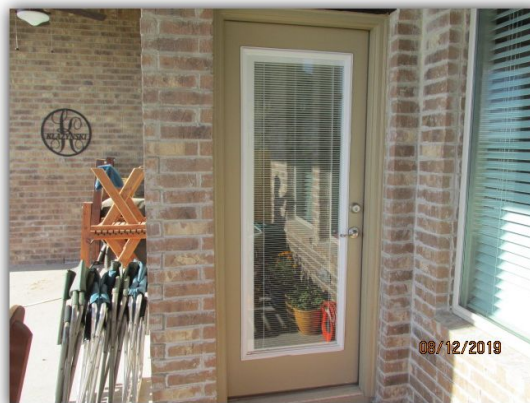
The back porch door appears to be out of square in its jamb also the [weather stripping](#) is in need of repair.

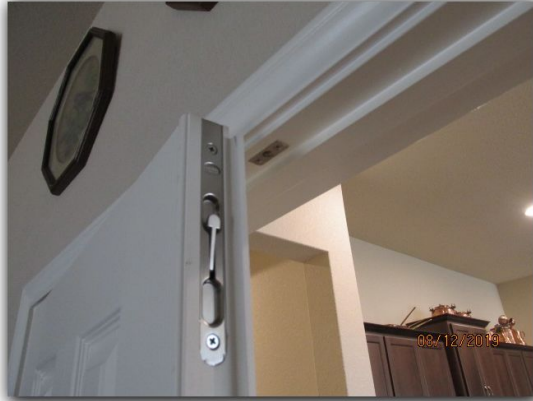
It was observed that the latching mechanism for the office door does not allow the door to be securely closed. Repair is recommended.

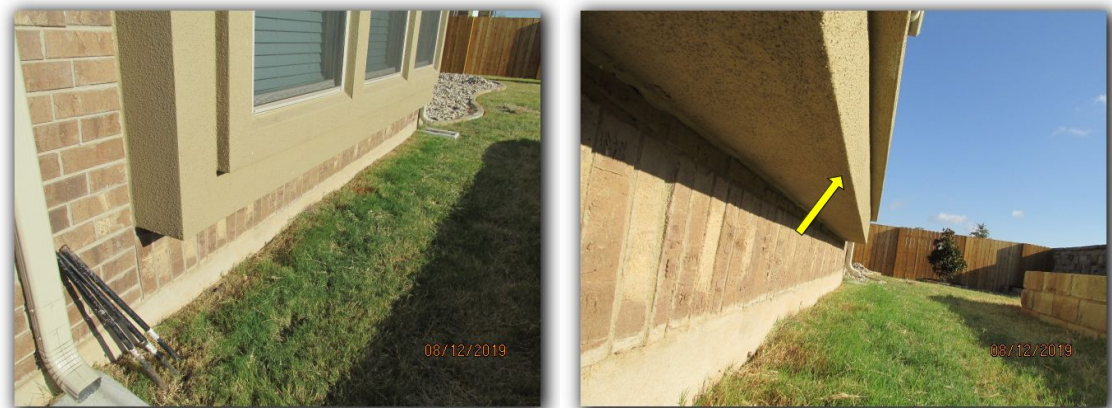
It was observed that the stucco bay window does not appear to be properly terminated at the exterior bottom. Per ASTM C 926 A 2.2.3, where vertical and horizontal exterior plaster surfaces meet, both surfaces shall be terminated with casing beads with the vertical surface extending at least 1/4 inch below the intersecting horizontal plastered surface, thus providing a drip edge. The casing bead for the horizontal surface shall be terminated not less than 1/4 inch from the back of the vertical surface to provide drainage. Monitoring and or repair is recommended.

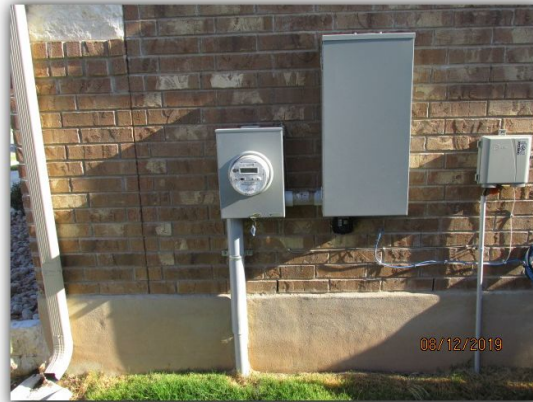
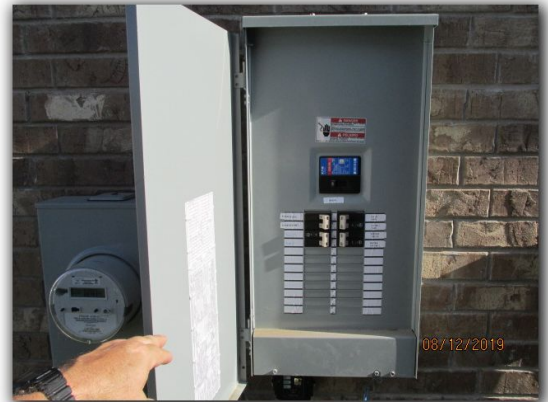
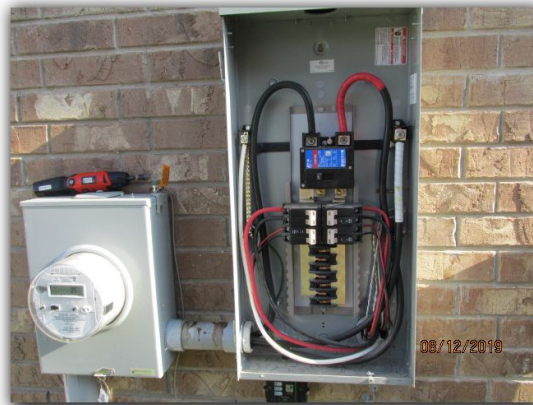
It appears that the #10 AWG conductor is too small for the 50 amp circuit breaker in the main panel. Oversized circuit breaker within the main distribution panel are recommended to be replaced. **This is a safety hazard.** Recommend having a licensed electrician to inspect system.

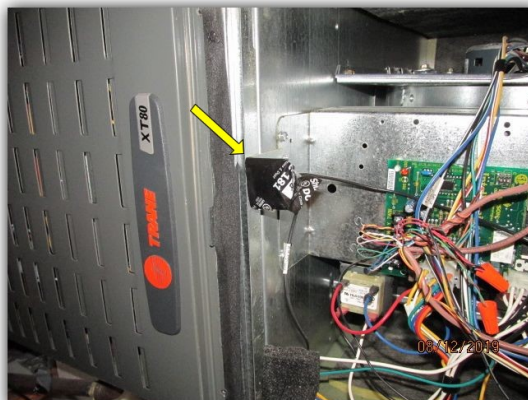
It was observed that the blower door safety switch on the HVAC air handler has been taped down in the "on" position. **This is a safety hazard** and repair is recommended.

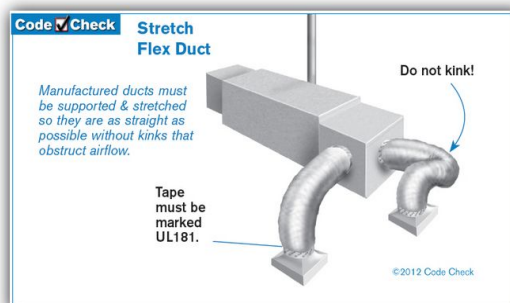
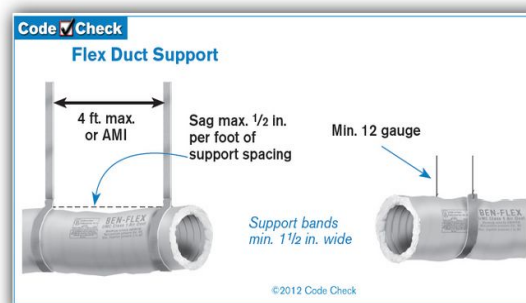
Improper routing of the flex duct was observed, in particular the duct for the whole house fan. It is required by current code and recommended by manufacturers that the insulated flex duct should be suspended from the attic rafters to help promote greater air flow on the outside of the flex duct to prevent possible condensation in humid climates. The flex duct should be installed without sags or tight turns that would inhibit proper air flow and reduce energy efficiency. Repair is recommended.

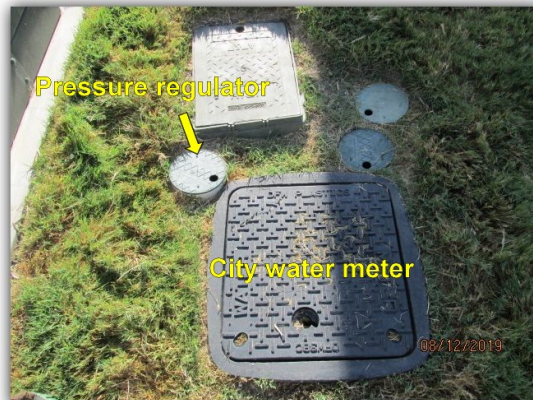
The required [private water valve](#) shut off was not located and should be exposed so that the valve will be accessible in the case of emergency as well as help prevent damage from rust if made of metal.

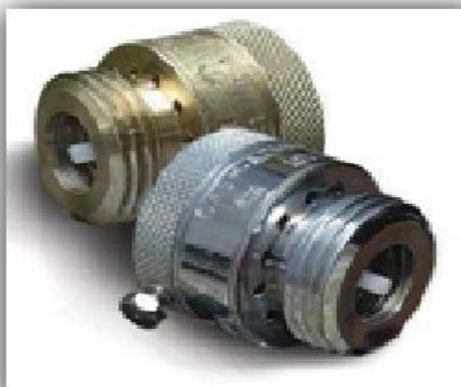
Exterior hosebib faucets do not have the [anti siphon back flow devices](#), as required by current code. Anti-siphon devices keep contaminated water from entering the potable water of the house plumbing. Repair is recommended.

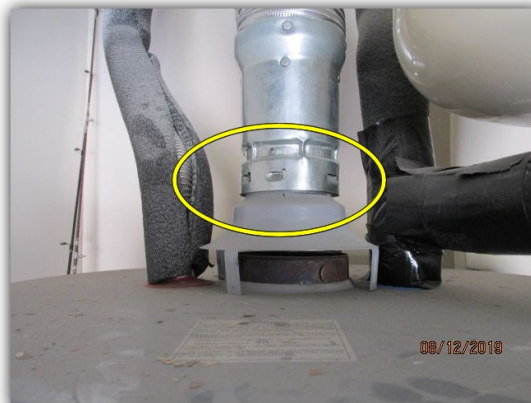
It does not appear that the gas flue pipe is not properly connected to the draft hood with two self tapping screws as required by the manufacturer. Repair is recommended.

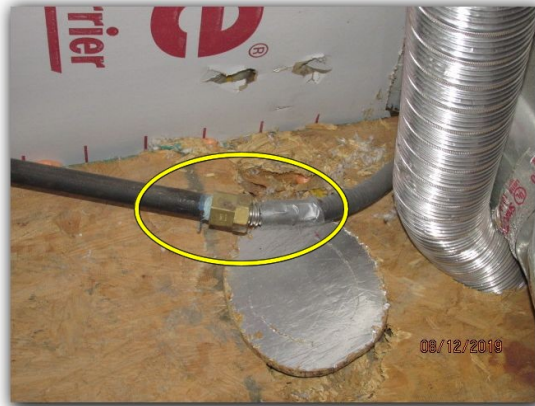
It was observed that the black jacket for the CSST has not been properly installed with the brass connector placed over the black jacketed sleeve and aluminum sleeve as required by the manufacturer. **This is a safety hazard.** Further investigation of the CSST and repairs are recommended.

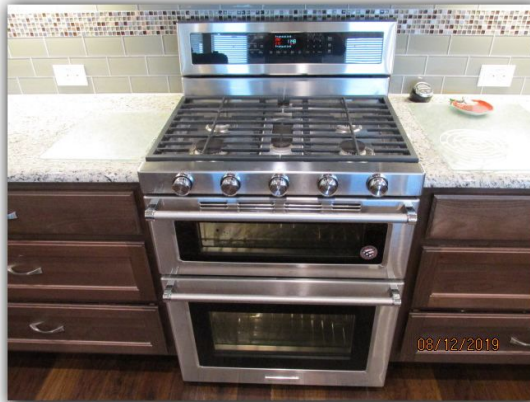
When the oven thermostat alarms sounded, the thermostats for the ovens were found to be inaccurate. The temperature was observed to be greater than a 25 degree difference, either cooler or warmer, of 350 degrees, as measured by a detached thermometer. Recommend further investigation and or repair by a professional appliance technician.

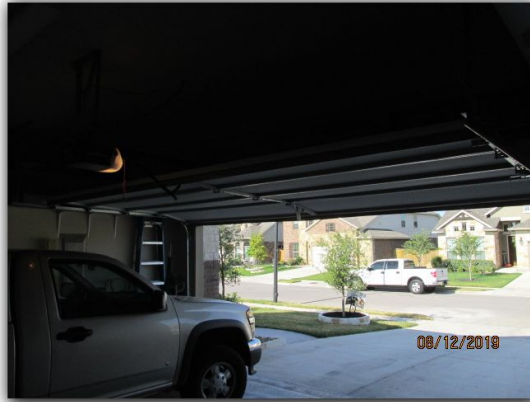
The door was observed to make popping noises during normal operation, suggesting that the door may be binding somehow. Recommend service by a qualified garage door professional.

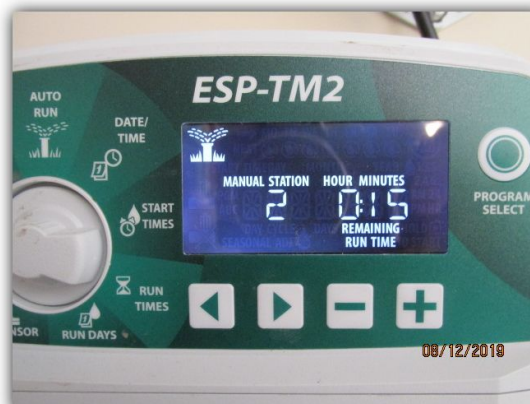
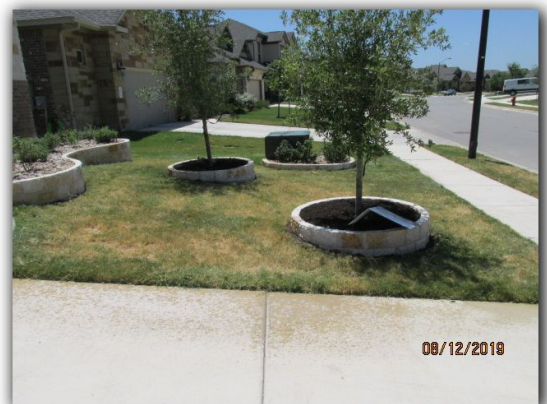
Recommend minor adjustment to the spray head[s] screw to help control overspray and wasting water on hard surfaces.

Recommend minor adjustment to a spray head for improved lawn coverage.

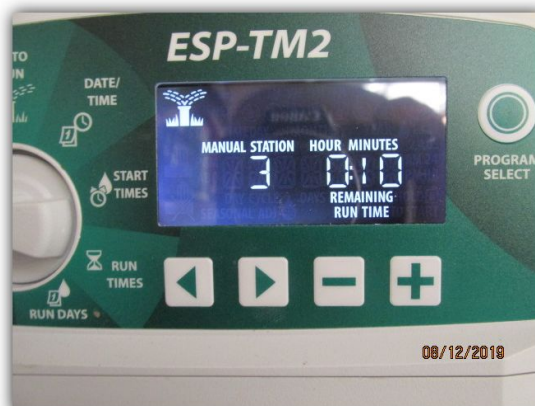
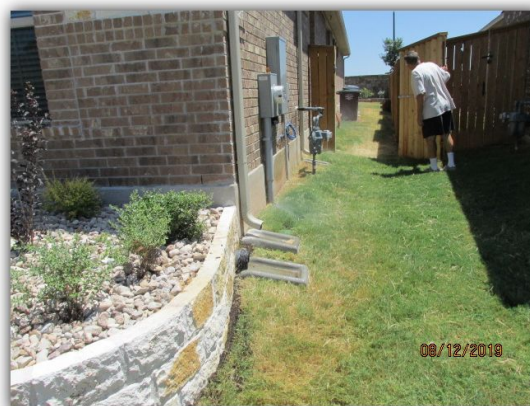
The water spray from the sprinkler heads should be re-directed away from the structure and/or fencing, decks, etc., to decrease the possibility of staining or damage. Changing and or adjusting the spray head[s] may be required.

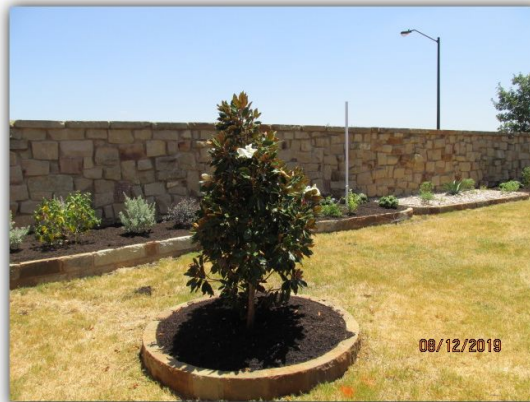
It was observed that this tree well was not watered in zone 5 even though it appears to be connected to the zone. Further investigation is recommended.

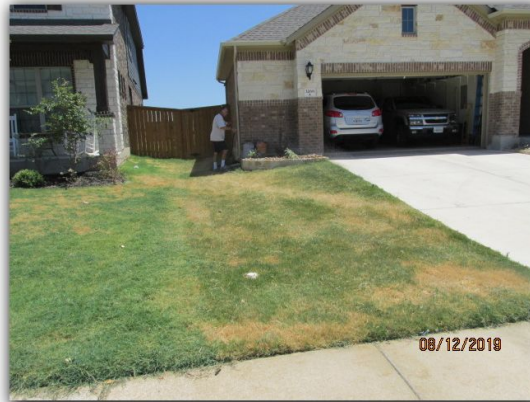
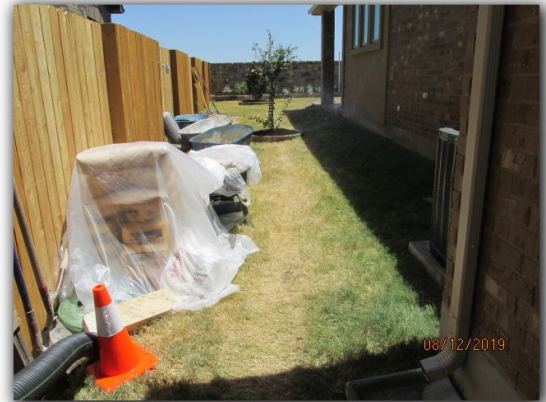
Recommend minor adjustment to the spray head[s] screw to help control overspray and wasting water on hard surfaces.

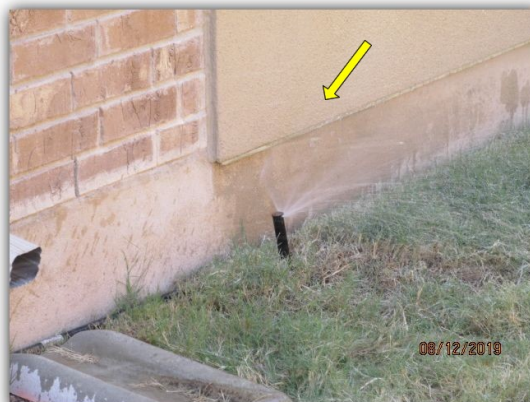
The water spray from the sprinkler heads should be re-directed away from the structure and/or fencing, decks, etc., to decrease the possibility of staining or damage. Changing and or adjusting the spray head[s] may be required.
